Corrosion Mechanism:
CO₂ flow induced corrosion

Alloy:
Plain carbon steel, J-55

Equipment:
Gas well 2³/₈" production tubing

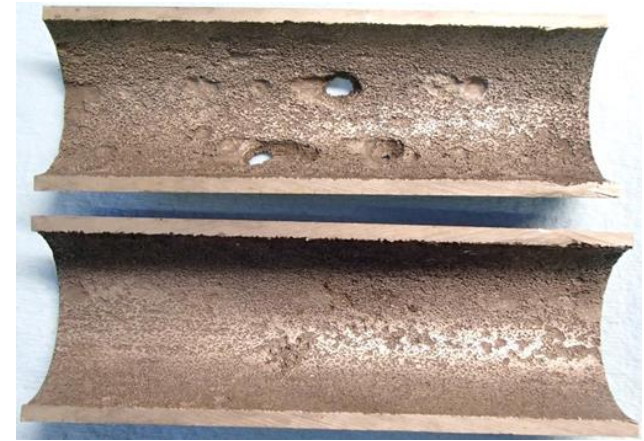
Corrosive Environment:
The production tubing is exposed to sweet natural gas containing 3.4% CO₂ at 2000 kPa and 5 °C. Produced brine has a low salinity.

Comments:
Carbon dioxide within the produced fluids provides an aggressive environment to the exposed steel. The gas velocity within the tubing is estimated at 9.7m/s which is high. Due to the high gas velocity, the majority of corrosion by-products that may eventually lead to a reduced corrosion rate is stripped away, providing bare steel to the corrosive well effluent. This corrosion mechanism is further impacted by the amount of solids or entrained liquids transferred with the gas stream.

Corrosion inhibitor will have limited effectiveness in reducing this type of attack.

Remedy:
Optimizing operational parameters such as increased well back pressure (reduced gas rates) or using larger diameter tubing will help to reduce severity of the issue. Changing metallurgy of the system can also improve the situation.
