Microbial Induced Corrosion (MIC)

NPS 3 emulsion flowline

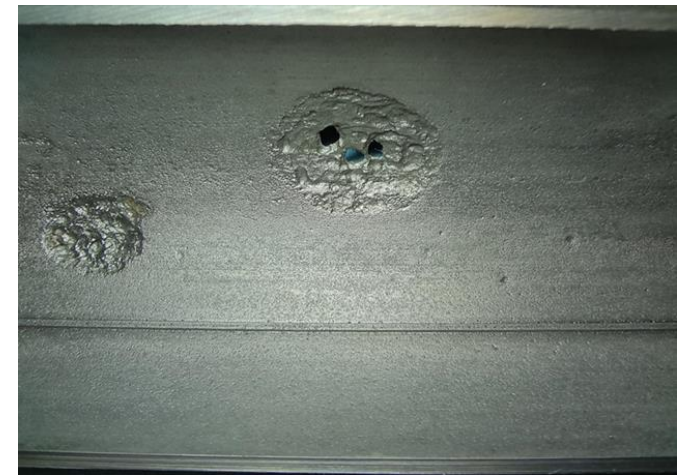
The line had been in operation for 45 years before the failure. The main defects (at 6:00 o'clock position) were large and circular in nature with sloping defect walls and evidence of edge attack. The pit internal surface was mottled with many ridges and non-uniform attack. This type of corrosion is indicative of MIC (sulfate reducing bacteria) where bacteria produce hydrogen sulfide by their metabolic activities adjacent to the pipewall under a biofilm; the sulfide can precipitate dissolved iron creating

bulky deposits that can accelerate corrosion.

The low fluid velocity in the system increases likelihood of solids deposition. This, in turn, can intensify severity of bacterial activity. Furthermore, lower pigging velocity due to low fluid velocity makes it more difficult for effective solids removal and allowance for the batch inhibitor to penetrate the solids deposited within the defects.

The line should be pigged aggressively and batched with a dose of an appropriate biocide. A normal batch inhibition program should then be capable of protecting the system.
