Corrosion Mechanism:

Oxygen corrosion

NPS 3 gas flowline

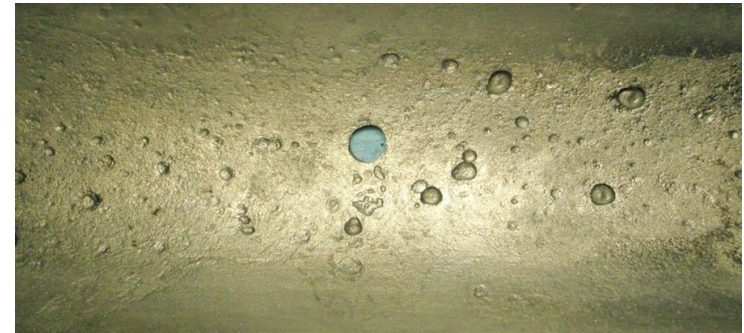
The failure pit had steeply sloping walls and was indicative of a dissolved oxygen corrosion mechanism. The failure occurred within the first 200m of the pipeline

which is also indicative of oxygen attack where it is relatively quickly consumed by corrosion reactions within the immediate downstream piping from its entry point.

Avoid reinjection of the oxygenated water into the gas line or use appropriate gas blanket on the tank to avoid oxygen ingress into the system.
