TLC (Top of the Line Corrosion)

NPS 4 emulsion flowline

Project Ref.: 16-002

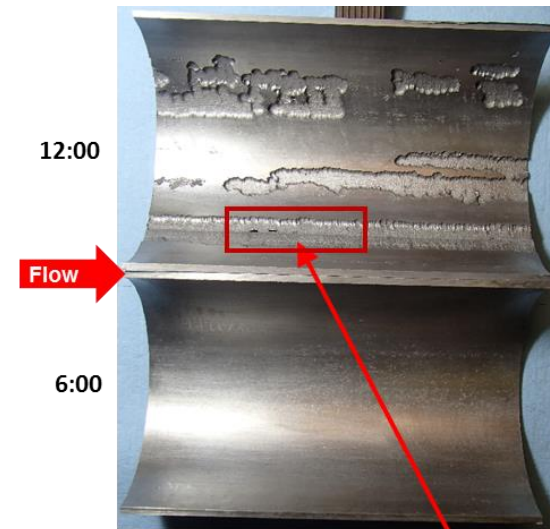
The line was in operation for 9 year before failure. The failure site was located along flat terrain approximately 50 meters from the individual well producing into the line. The line was not under any corrosion inhibition program and there was no pigging to promote fluid wetting to the top pipe position. It was identified that corrosion mechanism is top of line corrosion due to acidity of condensed water created by the presence of acid gases (CO<sub>2</sub>

and H<sub>2</sub>S) and volatile organic acids.

Failure line at ERW (11:00)

Pigging in combination with batch corrosion inhibition program is required to provide a protective film on top of the line in contact with the vapor phase in the line.

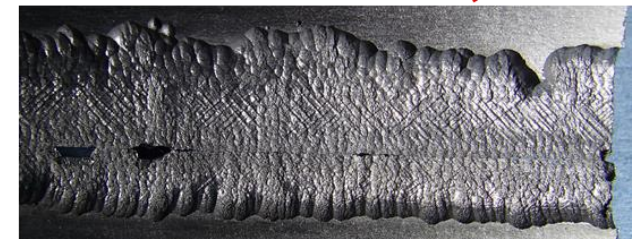
There was no internal corrosion activity to the bottom or lower side wall indicating the low salinity produced brine with a near neutral pH in combination with hydrogen sulfide and a low operating temperature results in a low corrosivity to steel in the water phase.
