CORROSION ASSESSMENT

ABC COMPANY 01-23-45-6 FLOWLINE

LICENSE # XYZ123-4

ABC Company 01-23-45-6 Flowline Corrosion Assessment

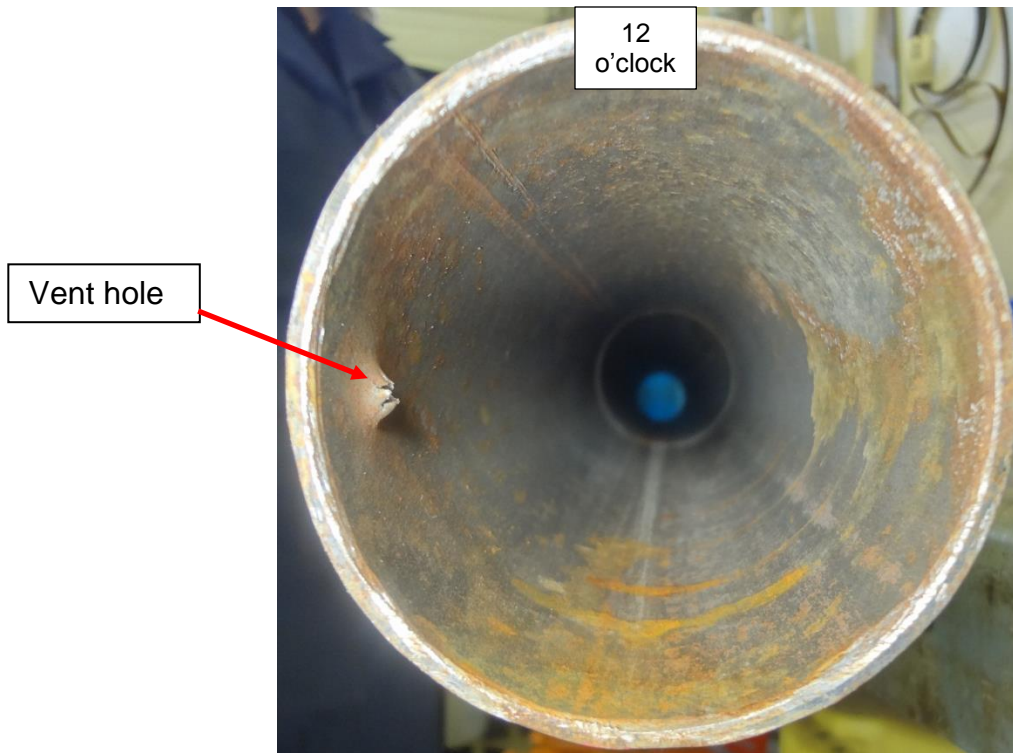
Figure 2: Internal Walls (Inlet), as received

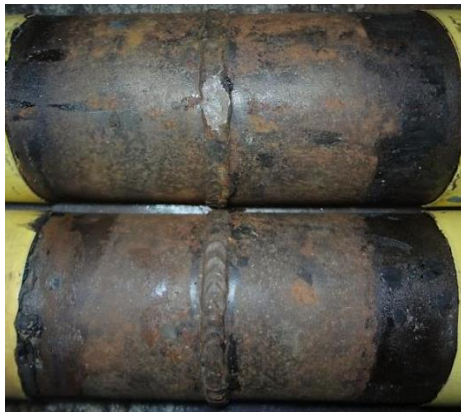
Figure 4: Girth Weld Area (External)

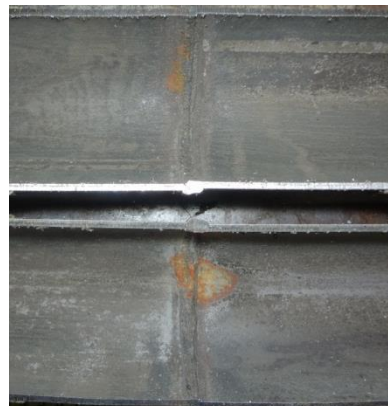
Figure 5: Girth Weld Area (Internal)

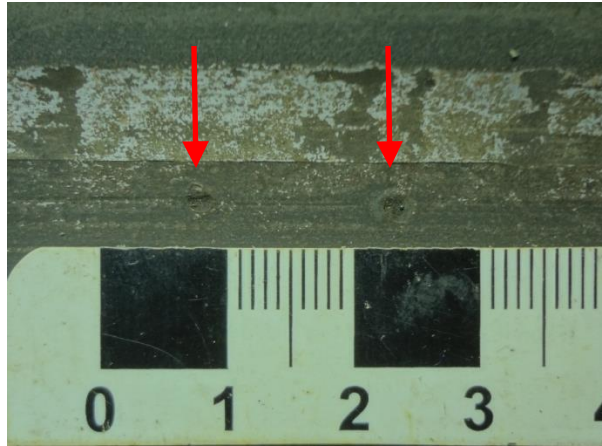
Figure 6: Pits located at 93 and 95.5cm from inlet (2 o'clock)

Internal pitting corrosion associated with ERW seam. Some defects appear to be mechanical in nature.

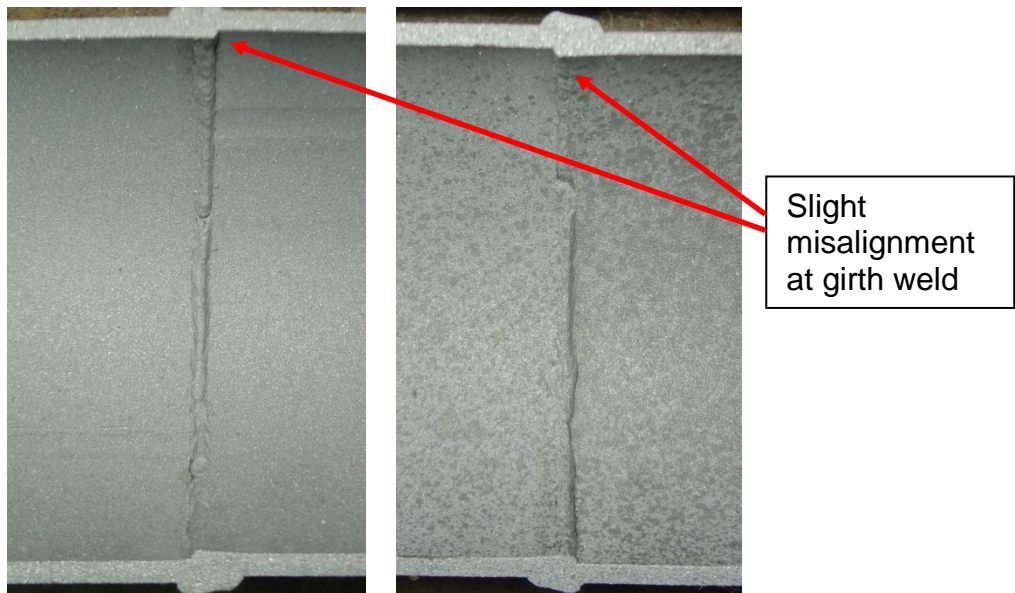
Figure 7: Girth Weld top and bottom slight misalignment

The pipe cut out was in good condition from an integrity standpoint. All defects were to less than 0.5 mm depth wall loss. The internal pits were associated with the ERW seam at the 2:00 o'clock orientation. A slight misalignment of the pipe segments was noted at the girth weld that would not impact pipeline integrity. The sample as received had minimal internal deposition indicating an effective pigging and batch corrosion inhibitor treatment program.

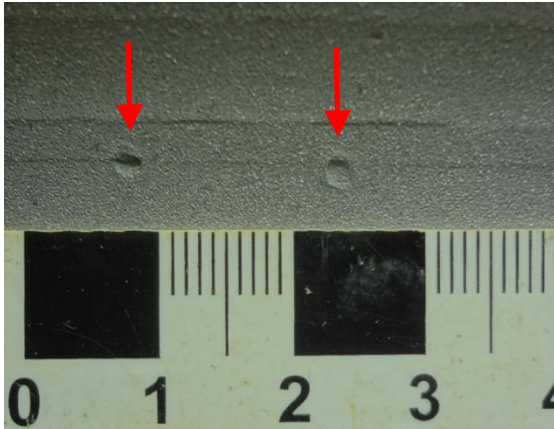
Figure 8: Pits-93& 95.5cm from inlet

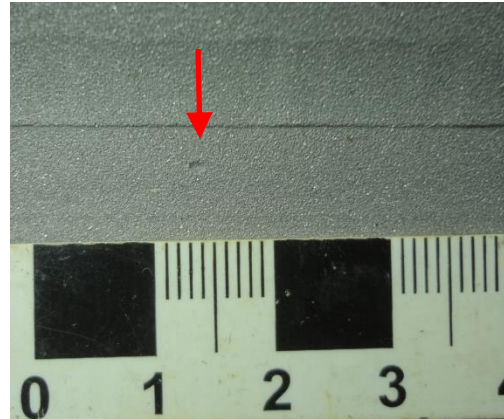
Figure 9: Pit-120cm from inlet

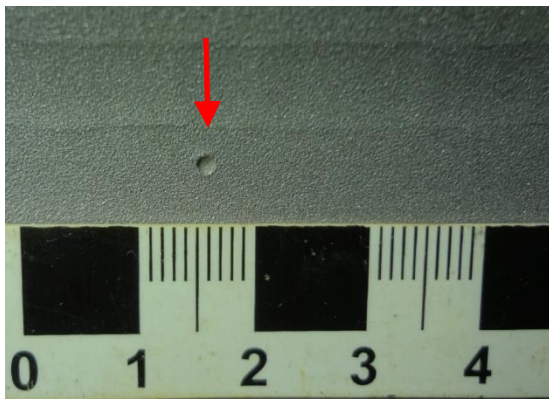
Figure 10: Pit-143cm from inlet

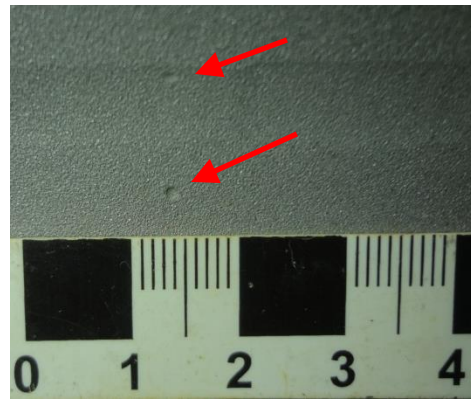
Figure 11: Pit-151cm from inlet
