File No. C25-XXX

Date: July 2, 2025

RE: CORROSION RING EVALUATION

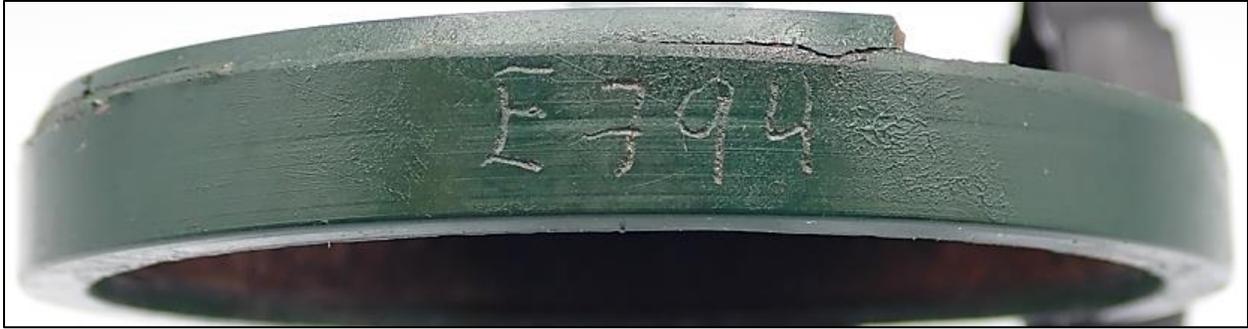
FIGURE 2: EXTERNAL SURFACE, AS RECEIVED

Rig #	Operator	Field Name	LSD	Coupon Location
Coupon #: E794	Part #: 35-11523P		Initial wt (g): 37.4937	Final wt (g): 37.1234
Depth In (m):	500	Date/Time (In):	5/19/25 12:00	
Depth Out (m):	1800	Date/Time (Out):	6/19/25 6:30	
Exposure (hr):	738.5	Corrosion Rate:	16.2 mpy	0.7 lb/ft2/yr
Before Cleaning:	Greased, damaged coating, mild brown deposition			
After Cleaning:	Low general corrosion, attack under damaged coating

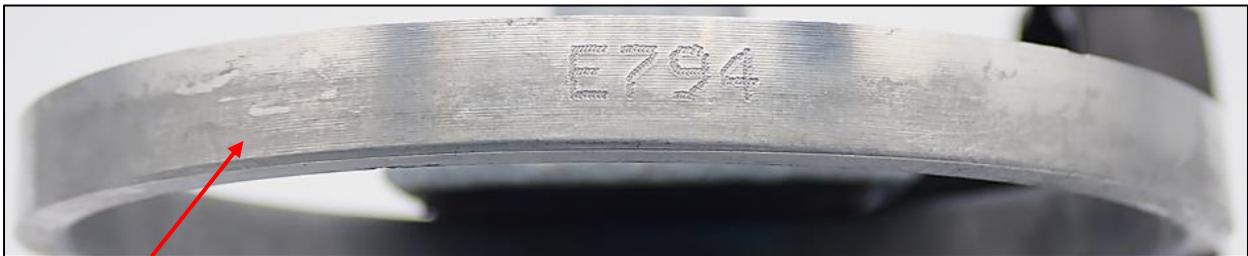
FIGURE 4: EXTERNAL SURFACE, POST-CLEANING

Attack to backside of ring
under damaged coating
